WEBROCK Final Report

WEATHER BUOY ROCKET  
FEASIBILITY STUDY

Prepared by: Michael Brian, Program Manager  
Prepared for: Office of Naval Research  
Physics Branch (Code 421)  
Washington, D.C. 20360  
Contract No.: Nonr 5013(00)  
Contract Authority No.: NR211-102/4-23-65  
Date: 25 April 1967

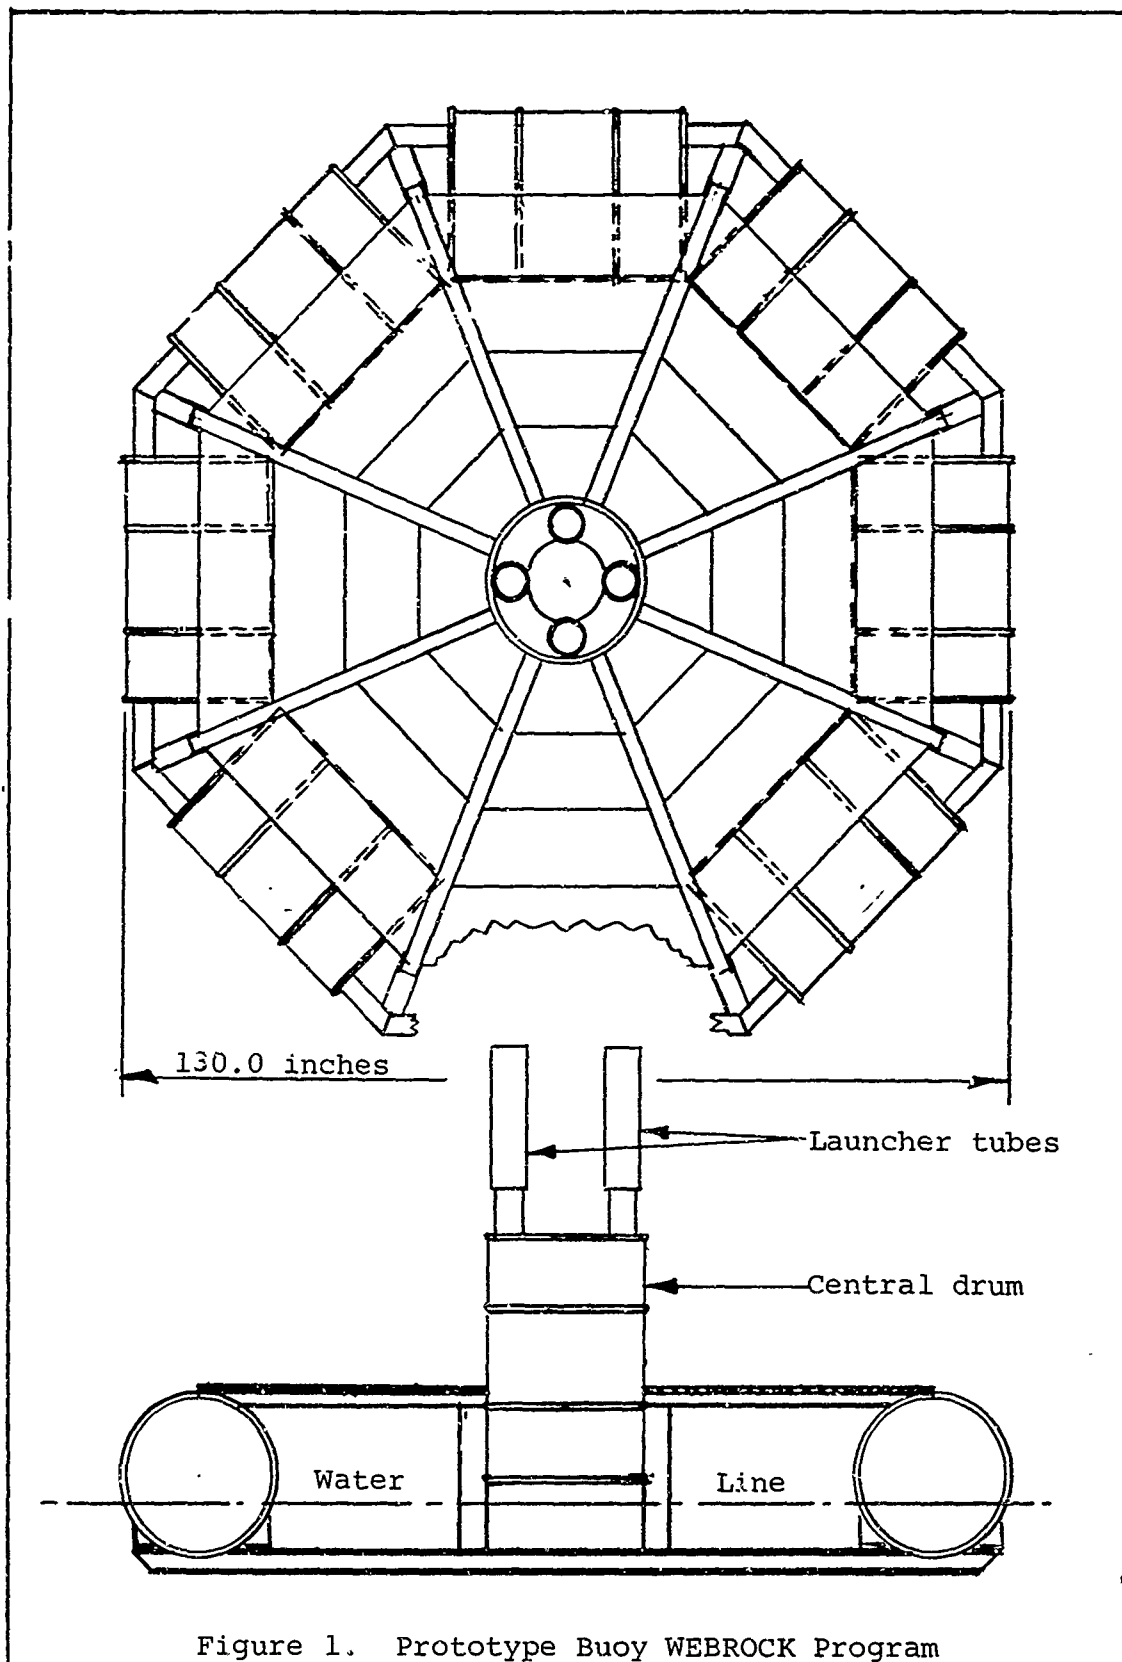
A prototype buoy was constructed, see Figure 1, incorporating eight 55 gallon oil drums arranged around the periphery in an octagonal configuration. One additional drum is located at the center of the buoy with its long axis vertical. The central drum contains the instrumentation, batteries, and four rocket launching tubes. The buoy is assembled by use of eight aluminum beams radiating from a pair of circular plates situated below the central drum. One inch thick wood flooring partially covers the outer drums allowing the central drum to project through. The buoyancy of the floating platform is approximately 3750 pounds; the total weight of the structure including rockets is 1140 pounds. The assembled buoy has a 12 inch draft and appears to ride quite stably.

Four open breech launch tubes are welded into the central drum and project through the drum at the ends. Both ends of the launch tube are taped to prevent moisture entering prior to firing and the central drum has a 12 inch diameter waterproof access panel bolted into the top. Contained in the drum are three tiers of equipment; the batteries at the bottom, the camera at the top with the lens projecting through a sealed aperture in the access panel, and the middle layer contains the mercury switches, timer and electronic gear.

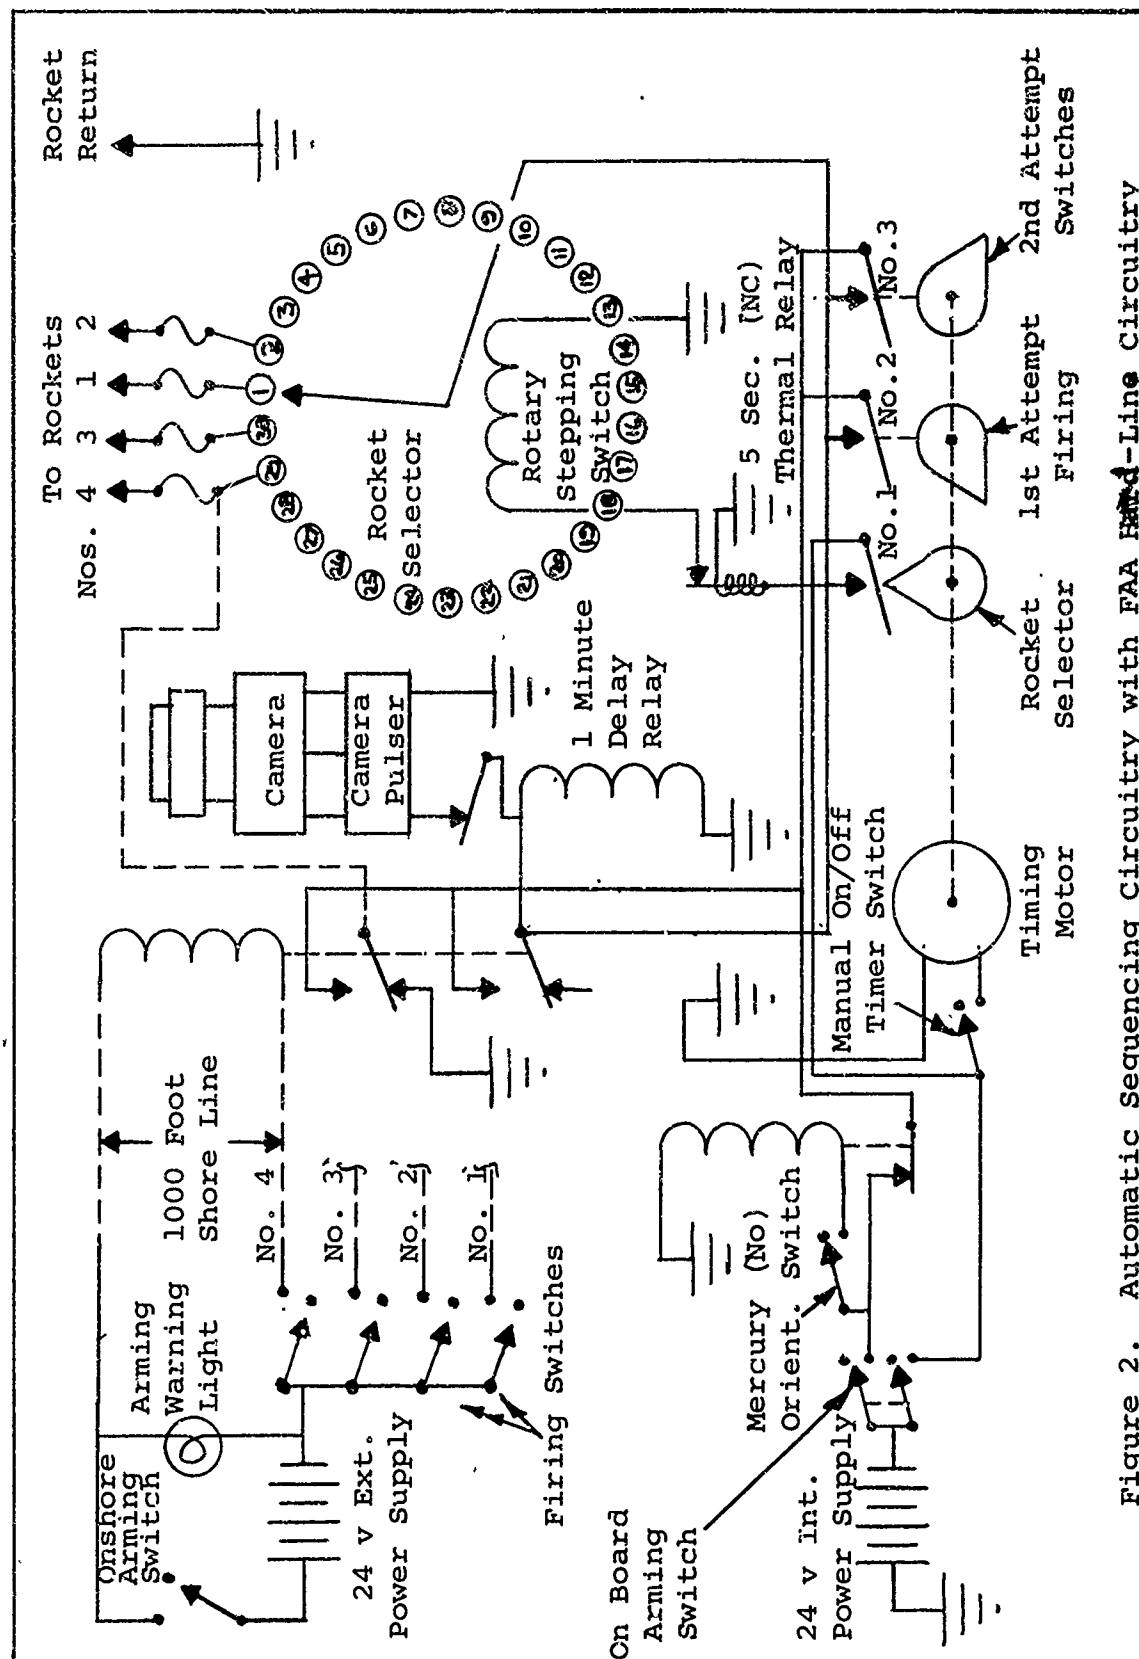
Figure 2. Automatic Sequencing Circuitry with FAA Hard-Line Circuitry

Lobes 2 and 3 also activate the skyward viewing camera for a sixty second period. The camera has a pulsing unit that causes an exposure rate of one frame per second. Figure 2 shows the circuitry in detail. The rotary stepping switch can accommodate up to thirty projectiles. The original intent was to fire two rockets and then allow the equipment to simulate rocket launches for twenty-six days during which time the system would be exposed to the environment. On the twenty-ninth and thirtieth days two more rockets were to be launched.

The 1000 foot shore line is extraneous to the needs of the circuitry for an automatic launch, therefore the connecting lines have been in dotted form rather than solid.

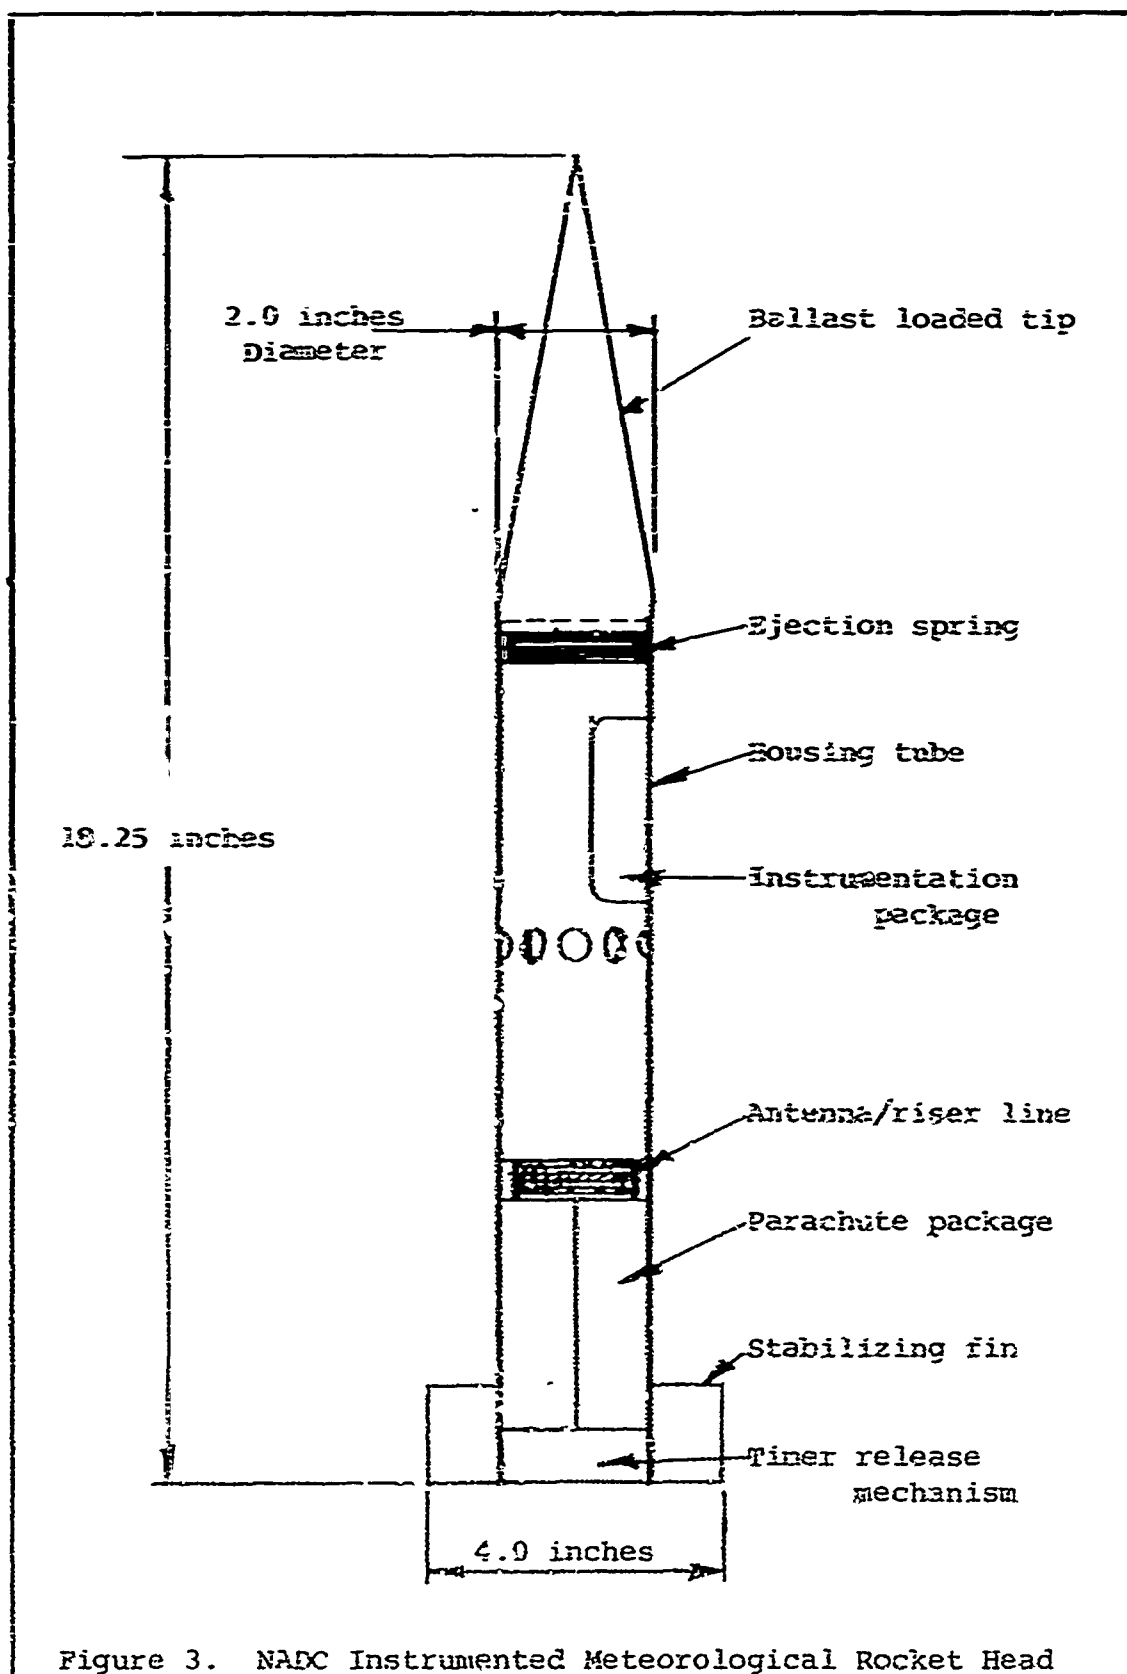
Figure 3. NADC Instrumented Meteorological Rocket Head

The rocketsonde instrumented package, as shown in Figure 3, monitors the temperature, humidity and pressure of the surrounding atmosphere during descent. At peak altitude the instrument package is ejected from the rocket head and transmission commences while an attached parachute controls the descent

rate. The rocketsonde operates on a nominal frequency of 403 mc. and contains an audio oscillator operating on a range of 25 to 225 cycles per second. A mechanically operated commutator continually monitors the three sensors (pressure, temperature and humidity); interspersed with the sensors are three reference resistors. The rotation of the commutator is held to between 2 and 3 rpm and the resulting transmission pattern is as shown:

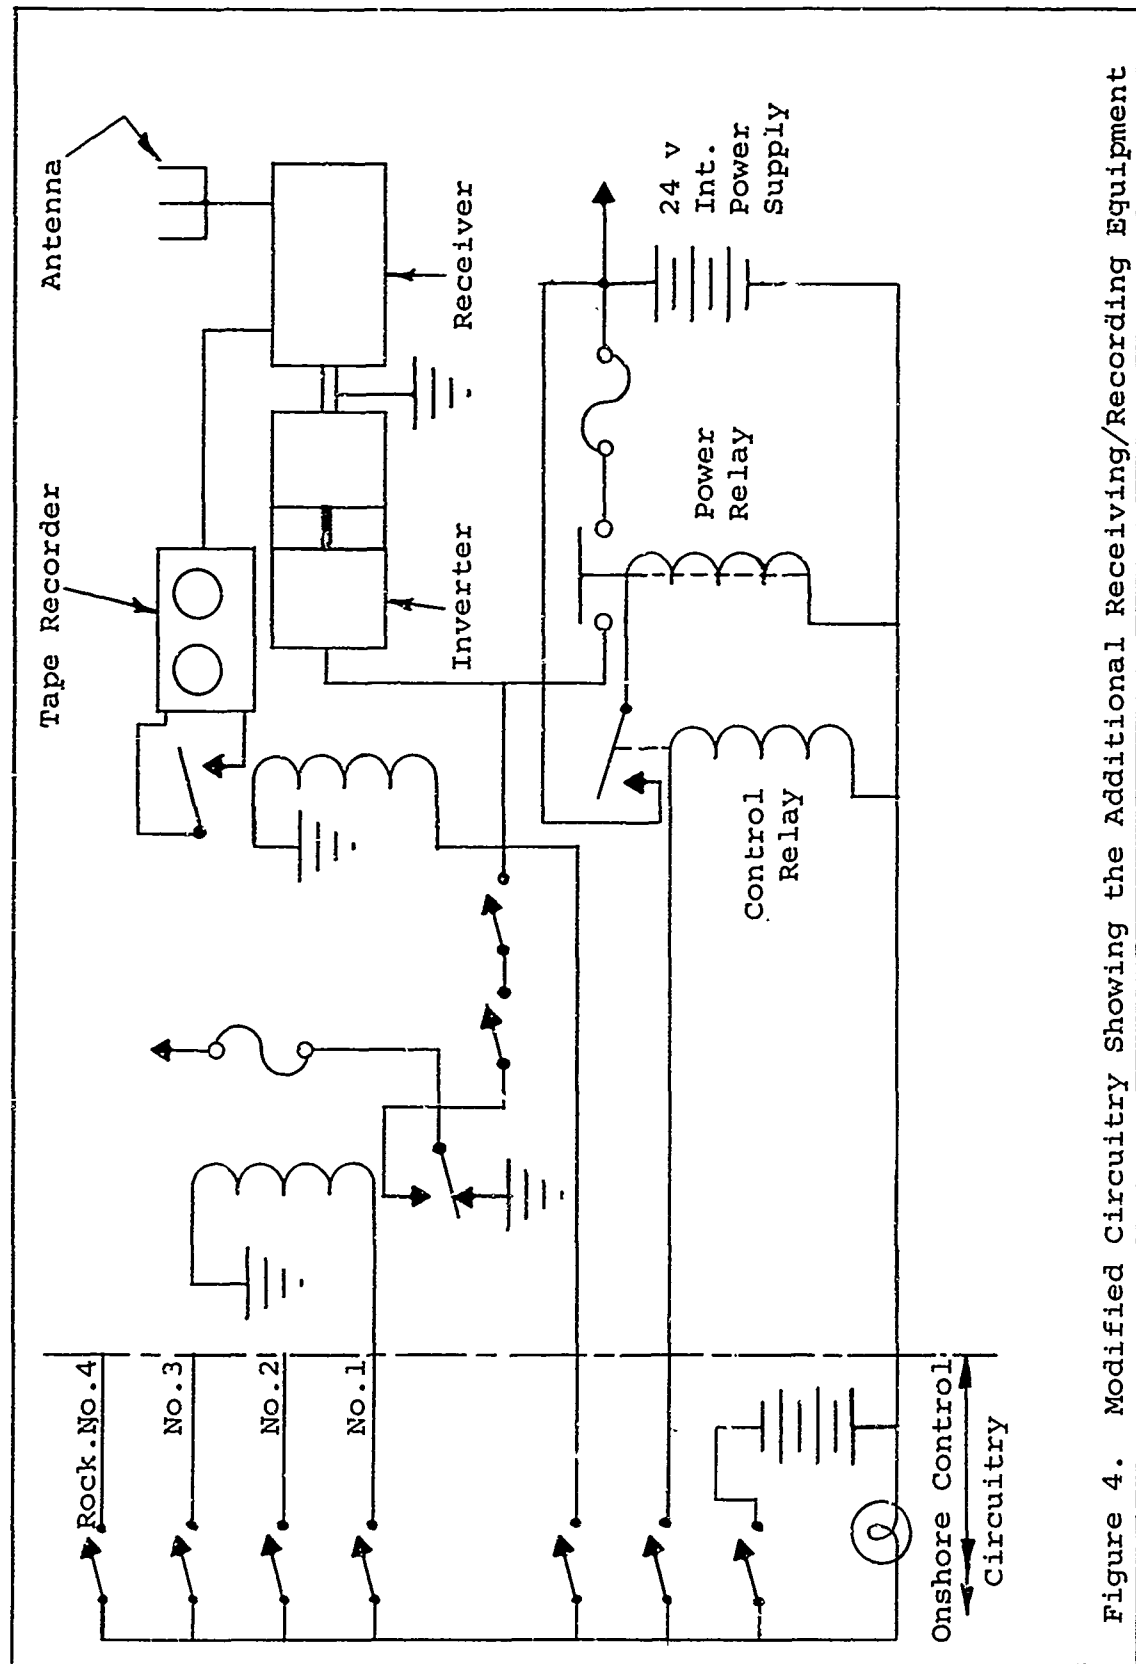
Figure 4. Modified Circuitry Showing the Additional Receiving/Recording Equipment

For the initial study (June 1965-March 1966) the equipment installed on the buoy was sufficient to prove feasibility of Hypothesis "A". Following the contract extension (March 1966-February 1967) it became necessary to supplement the electronics contained in the central drum. To validate Hypothesis "C" in its entirety was considered impractical and uneconomic at the time. Therefore it was decided to concentrate on receiving the transmitted rocketsonde signals and recording the information aboard the buoy. The justification for this approach was based on the premise that eventually the system will be integrated with the NOMAD buoy. The latter is already equipped with a powerful transmitter and is considered adequate for retransmission of the rocketsonde signals to a monitoring shore station. Figure 4 indicates the modified circuitry.

The skyward facing camera was removed from the central drum and a receiving unit plus a small portable tape-recorder substituted. The opening in the drum top (for the camera lens) was sealed off and an antenna mount was welded to, and slightly above, No. 4 Rocket Launch Tube in such a manner as to ensure water tightness of the installation.

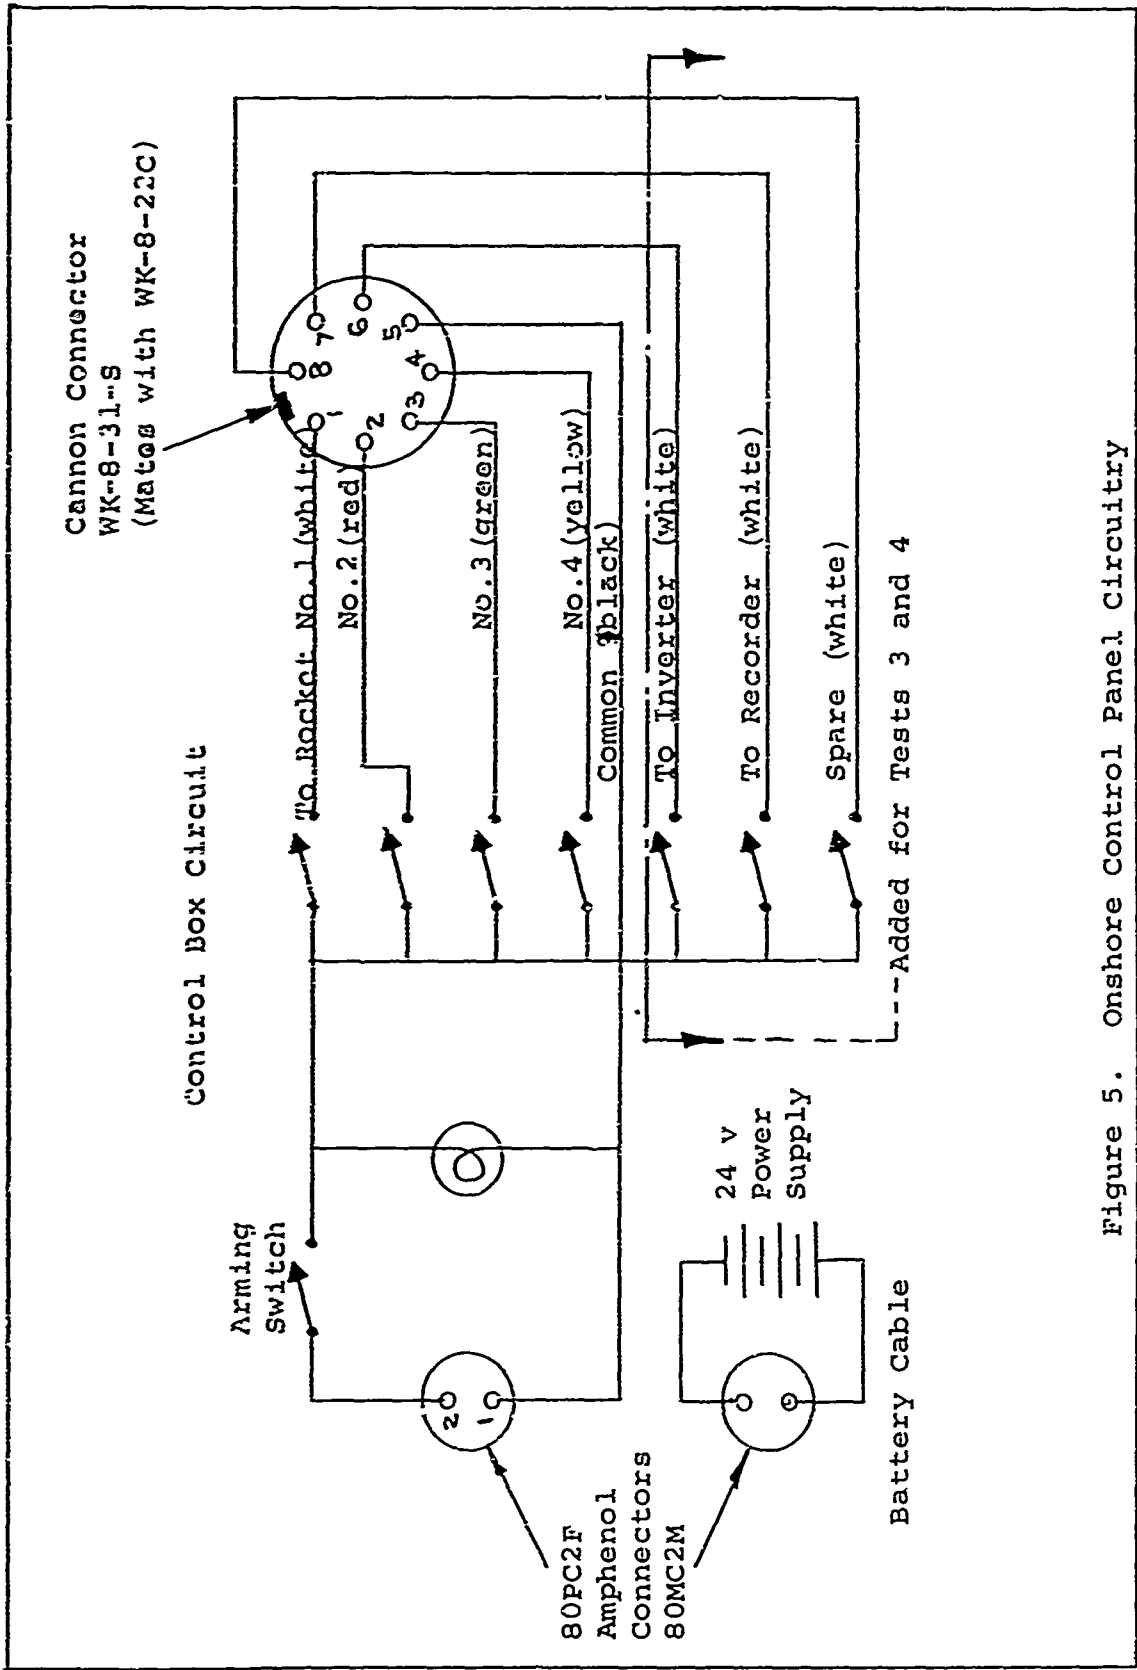
Figure 5. Onshore Control Panel Circuitry

The tape recorder is a small self-contained battery powered unit capable of accepting 5.0 inch reels. One mil magnetic tape at a recording speed of 3.75 inches per second allows a recording time of approximately 80 minutes per side. An onshore control for the tape recorder was designed into the system to conserve power and tape. Figure 5 indicates the onshore control panel schematic.

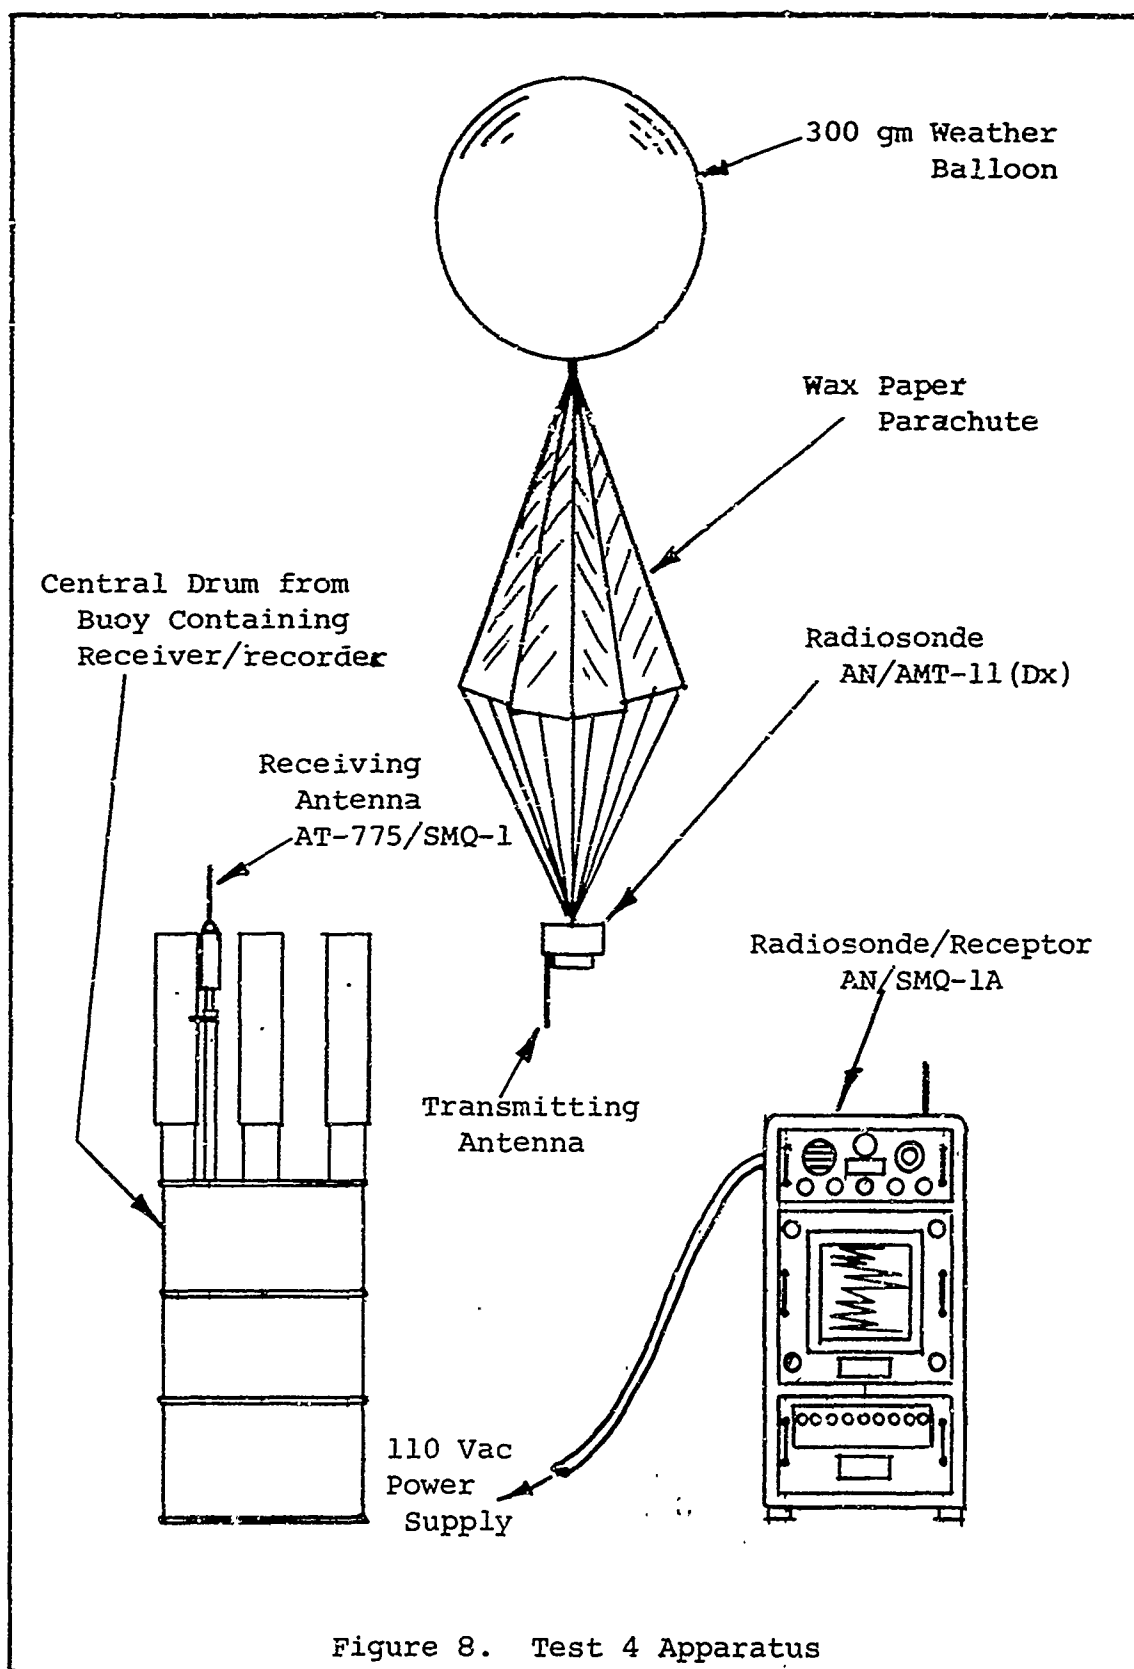
Figure 9. Physical Displacement of Radiosonde to Receiver

The tape recorder was set in motion and the balloon released. Both units continued to receive the signal until switched off 45 minutes later. Figure 9 indicates the predicted horizontal distance covered by the balloon during ascent. The prediction was based on a wind data plot for that day obtained from the U.S. Weather Bureau at Flint, Michigan (40 miles distant). The altitude plot was obtained by counting the number of reference signals emitted by the radiosonde during the ascent and comparing with the calibration sheet.
